WANTASTIQUET LAKE  
VT00073

PHASE I INSPECTION REPORT  
NATIONAL DAM INSPECTION PROGRAM

DEPARTMENT OF THE ARMY  
NEW ENGLAND DIVISION, CORPS OF ENGINEERS  
WALTHAM, MASS. 02154

AUGUST 1978

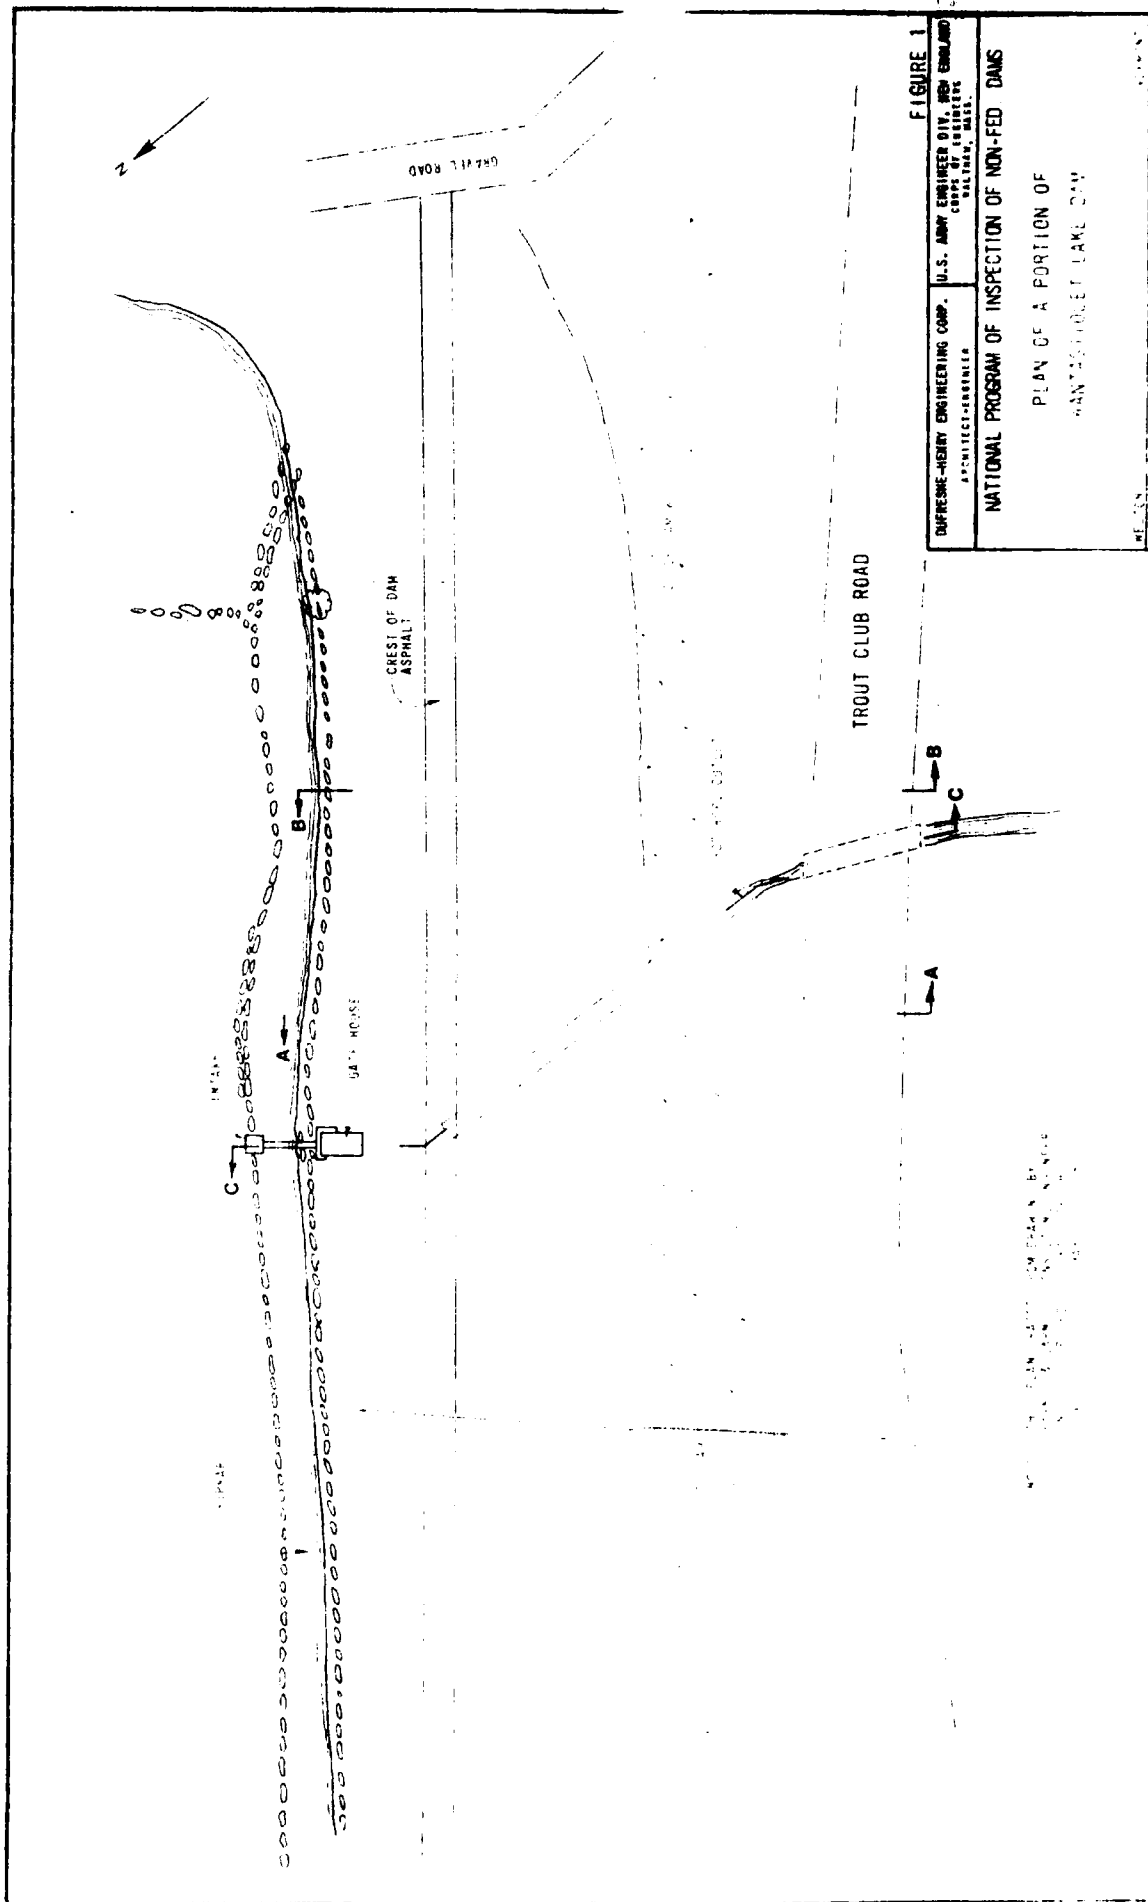
FIGURE 1

PLAN OF A PORTION OF  
HANTONSET LAKE DAM

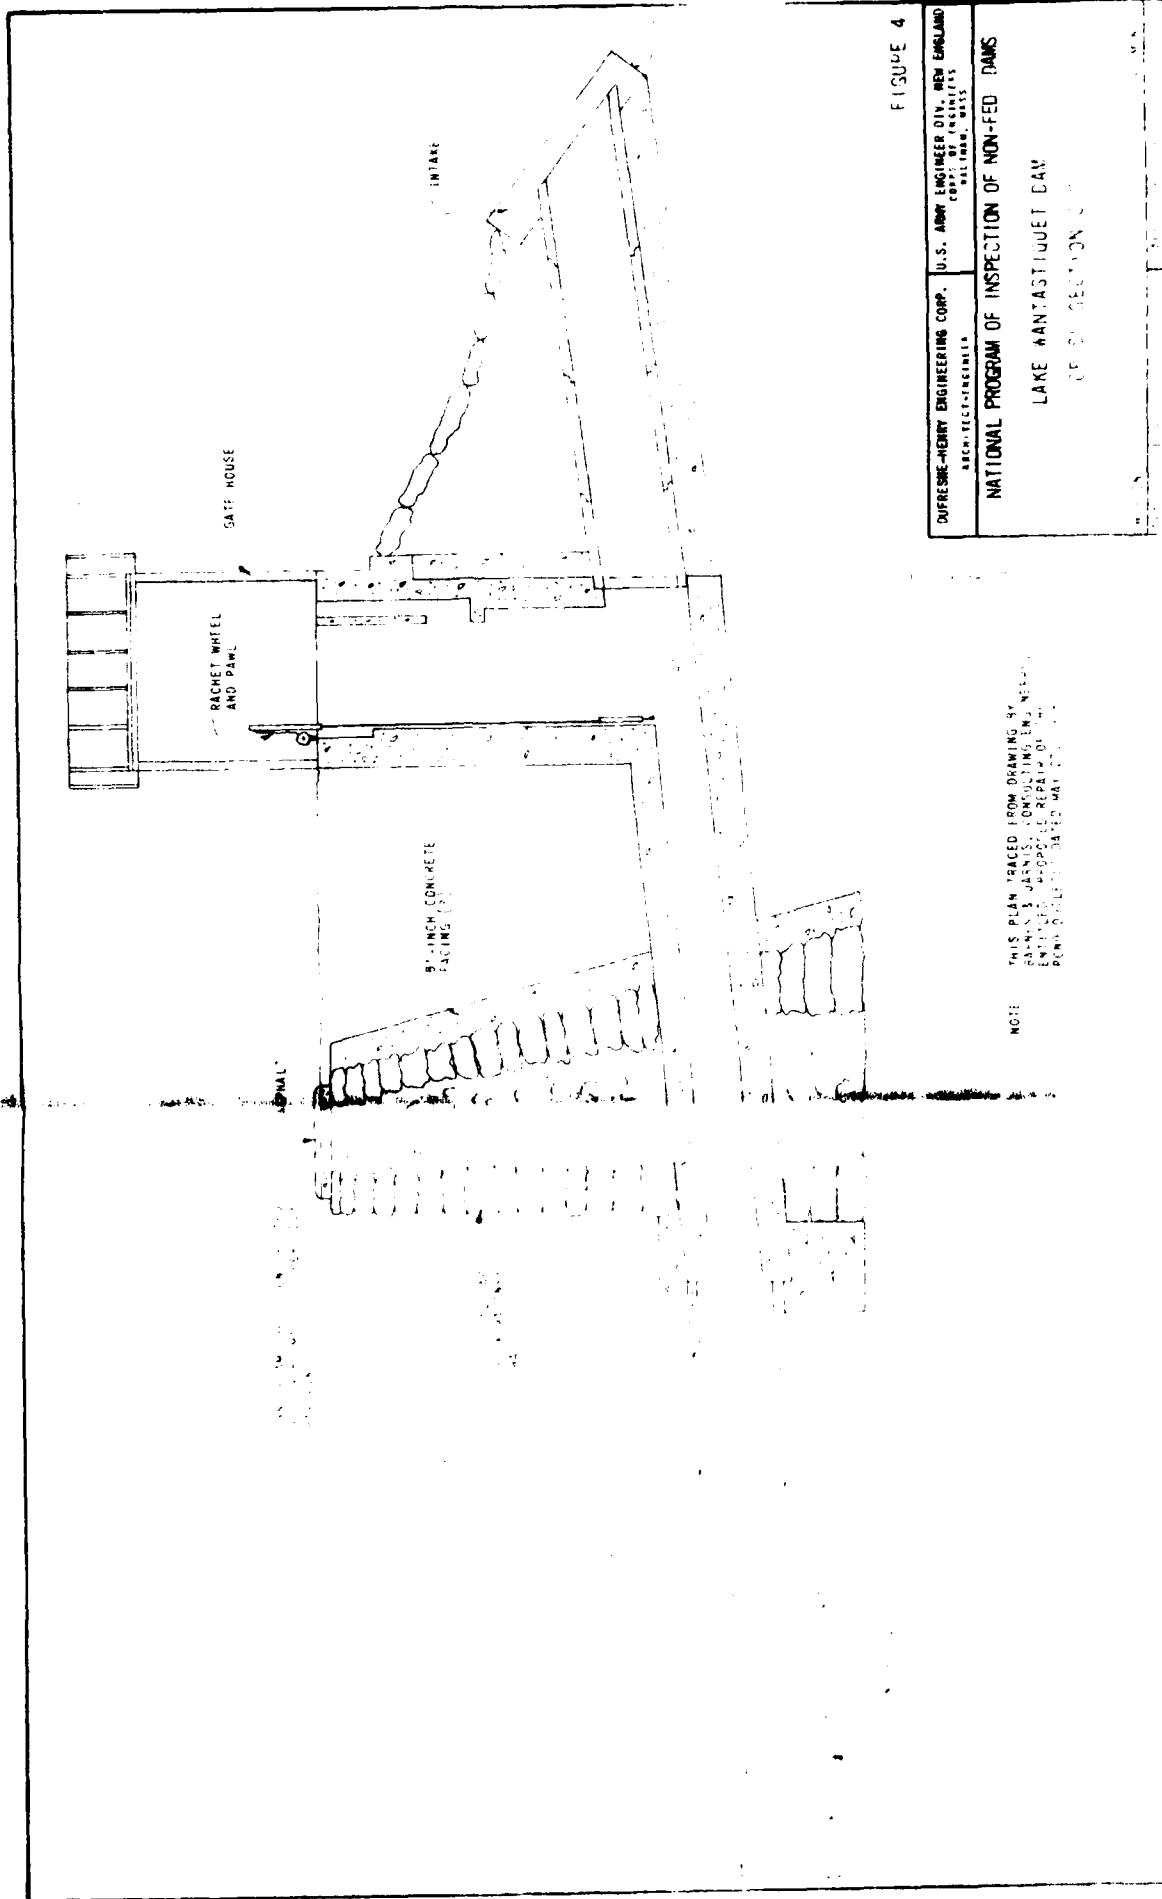
FIGURE 4

The outlet works consist of a submerged concrete block intake structure, a small gate house with a wooden slide gate, and the concrete outlet pipe located approximately at the center of the dam. The intake structure is comprised of a concrete block supporting the end of the 30-inch diameter intake conduit. The center of the inlet is located about 15 feet north of the gate house. Riprap has been placed on a 2:1 slope from the top of the concrete facing at the inlet to the edge of the gate house. The intake conduit flows about 15.5 feet at a 12 per cent slope into the gate house structure. The outlet pipe is 160 feet long and falls 6.8 feet through the embankment. The upstream invert elevation is 1760.5 feet m.s.l. and the downstream invert elevation is 1753.7 feet m.s.l. Refer to Fig. 4 in Appendix B.

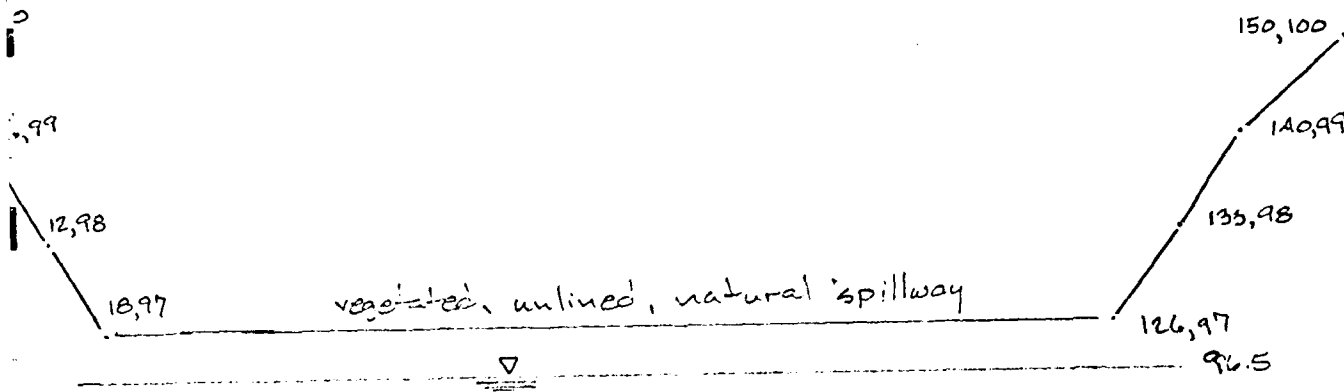
Spillway No. 2

Downstream channel slope  $\approx 3\% < 1.8\%$   $\therefore$  conditions for critical flow downstream of the spillway exist and submergence by tailwater will not be considered.
